DEPARTMENT OF THE ARMY

EVANGELINE PARISH WARD 3 INDUSTRIAL PARK SITE CERTIFICATION WETLAND DATA REPORT APPROXIMATE 100 ACRE TRACT EVANGELINE PARISH, LOUISIANA

C-K Associates' Project No. 6533

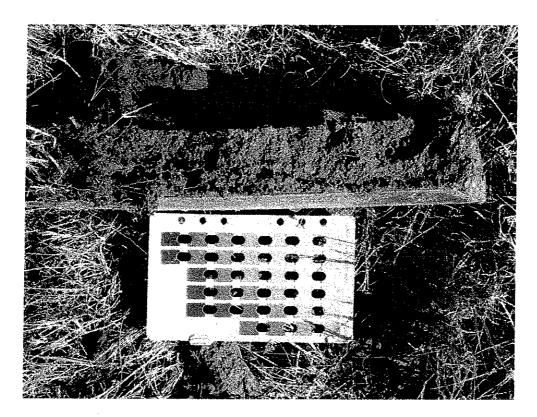
DP1 Soil Profile

Exhibit 17 - Wetlands Report SOIL Sampling Point: DP1 Profile Description: (Describe to the depth needed to document the indicator or confirm the absence of indicators.) Redox Features (inches) Color (moist) Color (moist) 0-10 10YR 4/3 100 silt loam 10-16 10YR 5/2 80 10YR 4/6 20 C silt loam Μ ¹Type: C=Concentration, D=Depletion, RM=Reduced Matrix, CS=Covered or Coated Sand Grains. ²Location: PL=Pore Lining, M=Matrix. **Hydric Soil Indicators:** Indicators for Problematic Hydric Soils³: _ Histosol (A1) Polyvalue Below Surface (S8) (LRR S, T, U) ___ 1 cm Muck (A9) (LRR O) _ Histic Epipedon (A2) Thin Dark Surface (S9) (LRR S, T, U) ___ 2 cm Muck (A10) (LRR S) ___ Black Histic (A3) Loamy Mucky Mineral (F1) (LRR O) ___ Reduced Vertic (F18) (outside MLRA 150A,B) ___ Hydrogen Sulfide (A4) Loamy Gleyed Matrix (F2) ___ Piedmont Floodplain Soils (F19) (LRR P, S, T) ___ Stratified Layers (A5) ___ Depleted Matrix (F3) ___ Anomalous Bright Loamy Soils (F20) ___ Organic Bodies (A6) (LRR P, T, U) __ Redox Dark Surface (F6) (MLRA 153B) ___ Depleted Dark Surface (F7) 5 cm Mucky Mineral (A7) (LRR P, T, U) Red Parent Material (TF2) __ Muck Presence (A8) (LRR U) ... Redox Depressions (F8) Very Shallow Dark Surface (TF12) (LRR T, U) _ 1 cm Muck (A9) (LRR P, T) Marl (F10) (LRR U) Other (Explain in Remarks) Depleted Below Dark Surface (A11) Depleted Ochric (F11) (MLRA 151) Thick Dark Surface (A12) Iron-Manganese Masses (F12) (LRR O, P, T) 3 Indicators of hydrophytic vegetation and Coast Prairie Redox (A16) (MLRA 150A) ___ Umbric Surface (F13) (LRR P, T, U) wetland hydrology must be present. ___ Delta Ochric (F17) (MLRA 151) Sandy Mucky Mineral (S1) (LRR O, S) Sandy Gleyed Matrix (S4) Reduced Vertic (F18) (MLRA 150A, 150B) Sandy Redox (S5) Piedmont Floodplain Soils (F19) (MLRA 149A) _ Stripped Matrix (S6) Anomalous Bright Loamy Soils (F20) (MLRA 149A, 153C, 153D) Dark Surface (S7) (LRR P, S, T, U) Restrictive Layer (if observed): Type: N/A Depth (inches): N/A **Hydric Soil Present?** Remarks: well drained area. No water in pit or on ground, despite recent heavy rains.

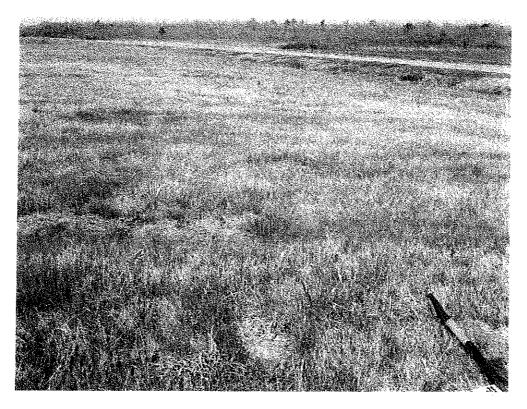
DP1 Habitat Photo

Plot located in mowed area south of road.					
HYDROLOGY					
Wetland Hydrology Indicators:	Secondar	y Indicators (minimum of two required)			
Primary Indicators (minimum of one is required; check all that apply)	Surfa	ace Soil Cracks (B6)			
Surface Water (A1) Water-Stained Leave	es (B9) Spar	sely Vegetated Concave Surface (B8)			
High Water Table (A2) Aquatic Fauna (B13)	Drain	nage Patterns (B10)			
Saturation (A3) Marl Deposits (B15)	(LRR U) Moss	Trim Lines (B16)			
Water Marks (B1) Hydrogen Sulfide Oc	lor (C1) Dry-5	Season Water Table (C2)			
	res on Living Roots (C3) Crayf				
Drift Deposits (B3) Presence of Reduce	-	ration Visible on Aerial Imagery (C9)			
		norphic Position (D2)			
Iron Deposits (B5) Thin Muck Surface (Inundation Visible on Aerial Imagery (B7) Other (Explain in Re		ow Aquitard (D3) Neutral Test (D5)			
Field Observations:	FAC-	Neutral Test (D3)			
Surface Water Present? Yes No _✓ Depth (inches): N/	A	}

Water Table Present? Yes No ✓ Depth (inches): N/					
Saturation Present? Yes No V Depth (inches): N	f	Present? Yes No			
(includes capillary fringe)					
Describe Recorded Data (stream gauge, monitoring well, aerial photos, pre	·				
Aerial photographs do not indicate wetland signature at plot Remarks:	location.				
Plot was taken in a slightly higher portion of the site.					
		į

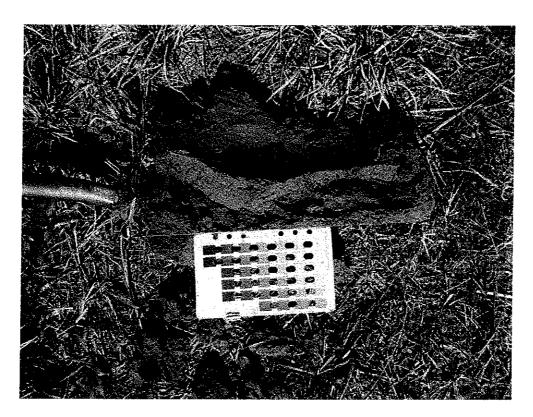
DP3 Soil Profile

(inches)	Matrix			Features				
ΩA	Color (moist)		Color (moist)	% Type¹	Loc ²	Texture	Remarks	
0-4	10YR 4/4	_ 100 _		<u>C</u>	<u> </u>	silt loam		
4-16	10YR 5/2	100		<u>C</u>	_ <u>M</u>	silt loam		
							· · · · · · · · · · · · · · · · · · ·

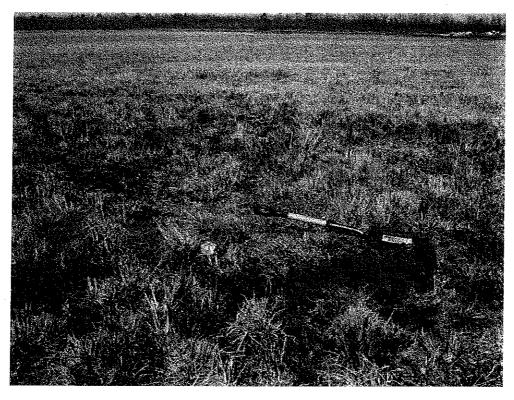
DP3 Habitat Photo

D. O	ction, Township, Range:
	cal relief (concave, convex, none): none Slope (%): 0%
	5.39"N Long: 92°16'10.86"W Datum: WGS84
Soil Map Unit Name: Patoutville-Crowley Complex	
	NWI classification: N/A
Are climatic / hydrologic conditions on the site typical for this time of year?	
Are Vegetation, Soil, or Hydrology significantly dis	turbed? Are "Normal Circumstances" present? Yes No
Are Vegetation, Soil, or Hydrology naturally proble	ematic? (If needed, explain any answers in Remarks.)
SUMMARY OF FINDINGS - Attach site map showing s	ampling point locations, transects, important features, etc.
Hydrophytic Vegetation Present? Yes ✓ No	to the Country Asses
Hydric Soil Present? Yes No	Is the Sampled Area within a Wetland? Yes No✓
Wetland Hydrology Present? Yes No	within a wetland? TesNo
Remarks:	
Plot located on a well drained area alongside ditch.	
HYDROLOGY	
Wetland Hydrology Indicators:	Secondary Indicators (minimum of two required)

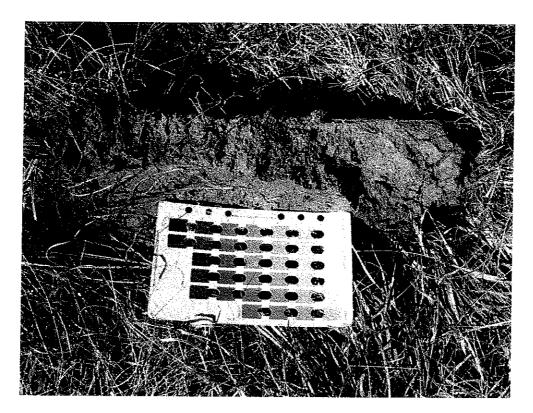
DP5 Soil Profile

SOIL Sampling Point: DP5 Profile Description: (Describe to the depth needed to document the indicator or confirm the absence of indicators.) Redox Features Color (moist) Color (moist) (inches) Type¹ Texture 0-8 10YR 4/4 100 C silt loam Μ 8-16 10YR 4/3 100 С silt loam Μ ¹Type: C=Concentration, D=Depletion, RM=Reduced Matrix, CS=Covered or Coated Sand Grains. ²Location: PL=Pore Lining, M=Matrix. **Hydric Soil Indicators:** Indicators for Problematic Hydric Soils³: Histosol (A1) Polyvalue Below Surface (S8) (LRR S, T, U) ___ 1 cm Muck (A9) (LRR O) Histic Epipedon (A2) ___ Thin Dark Surface (S9) (LRR S, T, U) ___ 2 cm Muck (A10) (LRR S) Błack Histic (A3) ___ Loamy Mucky Mineral (F1) (LRR O) ___ Reduced Vertic (F18) (outside MLRA 150A,B) Hydrogen Sulfide (A4) ___ Loamy Gleyed Matrix (F2) Piedmont Floodplain Soils (F19) (LRR P, S, T) ___ Depleted Matrix (F3) Stratified Layers (A5) __ Anomalous Bright Loamy Soils (F20) ___ Redox Dark Surface (F6) Organic Bodies (A6) (LRR P, T, U) (MLRA 153B) ___ Depleted Dark Surface (F7) 5 cm Mucky Mineral (A7) (LRR P, T, U) Red Parent Material (TF2) ___ Redox Depressions (F8) Muck Presence (A8) (LRR U) _ Very Shallow Dark Surface (TF12) (LRR T, U) _ 1 cm Muck (A9) (LRR P, T) Marl (F10) (LRR U) Other (Explain in Remarks) ___ Depleted Ochric (F11) (MLRA 151) Depleted Below Dark Surface (A11) Iron-Manganese Masses (F12) (LRR O, P, T) Thick Dark Surface (A12) ³Indicators of hydrophytic vegetation and Coast Prairie Redox (A16) (MLRA 150A) ___ Umbric Surface (F13) (LRR P, T, U) wetland hydrology must be present. Sandy Mucky Mineral (S1) (LRR O, S) ___ Delta Ochric (F17) (MLRA 151) ___ Sandy Gleyed Matrix (S4) Reduced Vertic (F18) (MLRA 150A, 150B) ___ Sandy Redox (S5) Piedmont Floodplain Soils (F19) (MLRA 149A) ___ Stripped Matrix (S6) ___ Anomalous Bright Loamy Soils (F20) (MLRA 149A, 153C, 153D) Dark Surface (S7) (LRR P, S, T, U) Restrictive Layer (if observed): Type: N/A Depth (inches): N/A **Hydric Soil Present?** Remarks:

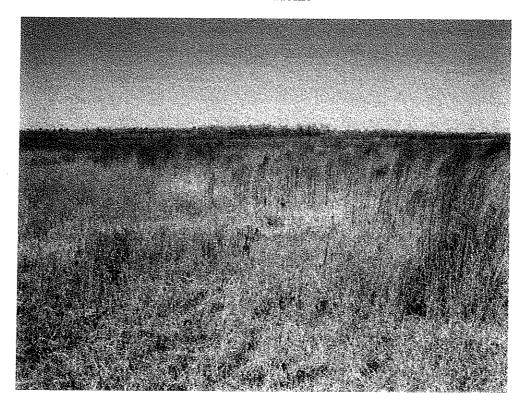
DP5 Habitat Photo

Hydric Soil Present? Yes No✓	Is the Sampled Area					
Wetland Hydrology Present? Yes No	within a Wetland?	Yes No				
Remarks:						
Plot taken in the tract north of the road in the southeast corr	er. The southeast con	ner of the northern tract is the only				
section north of the road that is not actively in agriculture. T						
baseball. Bases and backstops are still present although th						
Y Y						
HYDROLOGY						
Wetland Hydrology Indicators:	Sec	ondary Indicators (minimum of two required)				
Primary Indicators (minimum of one is required; check all that apply)		Surface Soil Cracks (B6)				
Surface Water (A1) Water-Stained Leaves	(B9)	Sparsely Vegetated Concave Surface (B8)				
High Water Table (A2) Aquatic Fauna (B13)	_	Drainage Patterns (B10)				
Saturation (A3) Marl Deposits (B15) (_RR Ü)	Moss Trim Lines (B16)				
Water Marks (B1) Hydrogen Sulfide Odd	or (C1)	Dry-Season Water Table (C2)				
Sediment Deposits (B2) Oxidized Rhizosphere	s on Living Roots (C3)	Crayfish Burrows (C8)
